Material Compatibility with Hybrid Hydrogen Peroxide on Critical Laboratory Equipment and Sensors after 125 Cycles of Exposure

Synopsis

This study sought to support normal pharmaceutical laboratory operations by exposing commonly used sensitive laboratory equipment, a particle counter, to 100 hours of hybrid hydrogen peroxide (HHP) biodecontamination. Following 125 decontamination cycles, this work assessed the impacts on the particle counter. Material compatibility was proven by two methods—zero-count testing and quality testing performed by the manufacturer. All zero-count tests produced successful results demonstrating no introduction of contaminants that would instigate false counts. Quality testing and inspection showed the particle counter's calibration remained in tolerance, finding no detrimental effects to material compatibility, optic sensors, or electronic function. Further, efficacy testing employing *Geobacillus stearothermophilus* biological indicators (2.2×10^6 population) demonstrated sporicidal efficacy of the HHP cycle even within areas of limited access on the particle counter itself (tested at 20-100 mm). This work supports laboratory functions demonstrating t

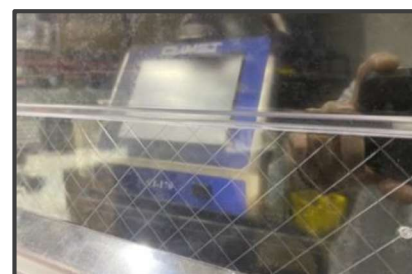
Figure 1. Particle counter during HHP decontamination cycle.

The particle counter was tested in a small enclosure under environmental conditions similar to those within a climate-controlled facility (Figure 1). The particle counter was open (dust cap removed) during decontamination cycles to allow exposure of the sensors inside the unit. In addition, the back panel and battery compartment were loosened to enable a gap for HHP to access the recesses of the particle counter. To reach 100 hours of exposure, 125 decontamination cycles were completed at an average of 46 minutes per cycle.

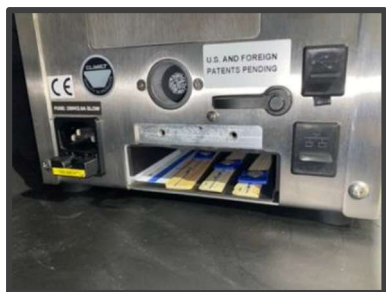
Figure 2. Photo of biological and chemical indicators placed within battery compartment of the particle counter.

Decontamination cycles were periodically measured for efficacy using *Geobacillus stearothermophilus* bacterial spore indicators at a population of 2.0×10^6 spores within the tested enclosure. Biological indicators (BIs), placed within the battery compartment of the device, were also used to measure the penetration of HHP into crevices of the particle counter at depths ranging from 20 mm to 100 mm (Figures 2 and 3). Following each validation cycle, BIs were aseptically transferred to tryptic soy broth and incubated at 57°C, observed for 7 days, and results recorded.

Further, chemical indicators supported these results, showing a color change to indicate HHP exposure both in the tested compartment and within the battery compartment of the particle counter.

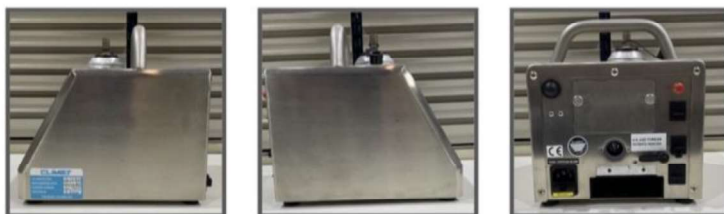
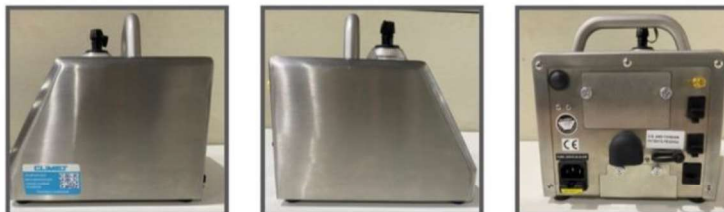
Before HHP Exposure

After HHP Exposure

Figure 4. View of the particle counter before testing and following 100-hour testing.

The exterior of the particle counter is primarily fabricated with a stainless-steel casing framing and an electronic display screen. Following 100 exposure hours, there were no observed physical changes to the materials comprising the particle counter (see Figure 4). The electronic display was fully operational, and the stainless-steel casing was unchanged, as verified by the manufacturer of the particle counter, Climet.

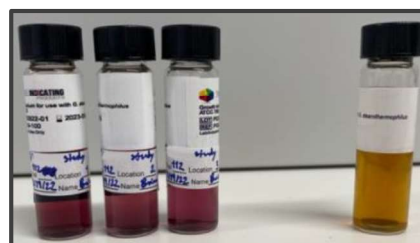
Figure 5. Biological indicators negative for growth post HHP treatment with one positive control.

A total of 41 challenged biological indicators used throughout the 125 decontamination cycles of this study demonstrated a 6-log sporicidal efficacy both adjacent to and in areas of limited access within the battery compartment of the particle counter. These efficacious results additionally demonstrate the 100-hour exposure to HHP is equivalent to what would occur under normal laboratory practices (Figure 5).
